STRUCTURE SMART

HOME INSPECTION REPORT

65 Belmont Place

Report Prepared For:
James Buyer

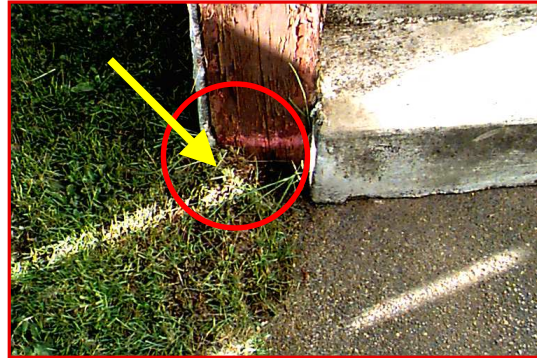
5) Portions of the wood deck are in contact with soil. This will most likely eventually result in rot and insect infiltration, even if the deck has been constructed from treated lumber. I recommend correcting the grading around the deck to achieve at least 3-4 inches clearance between any wood components and soil. Sometimes, this is esthetically impossible due to landscaping. In such circumstances, I recommend creating a border around the deck using pavers and placing river-washed stone or lava beneath the members. This way, the existing grade surface can be retained while providing good drainage beneath the members.

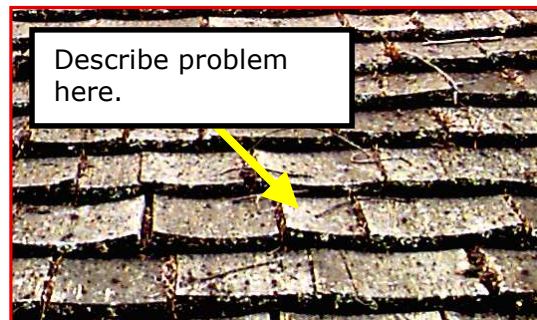
3) The wood roof cover on this home has numerous rotting or missing shakes or shingles. However, being organic that inherent protection eventually breaks down and the cover is always subject to damage caused by weathering. This characteristic makes it necessary to have the cover periodically cleaned and inspected by a wood roof professional, which can replace rotted/missing shakes and best determine when failure and replacement of the cover is imminent. Immediate evaluation by a wood roof professional and repair or replacement of the cover as appropriate is recommended.

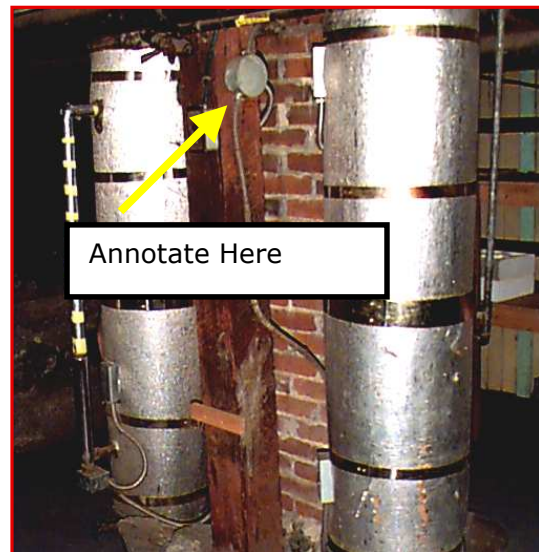
1) **AREA OF CONCERN:** All of the supply water, whether hot or cold, is brown with rust when drawn. This normally indicates the minor rusting that takes place inside galvanized pipe when the water hasn't been run for several days. Such minor rust will normally flush out of the system within 20 - 40 seconds of the tap being opened. However, I ran the water for some minutes, in order to flush the residue out of the plumbing, and was unsuccessful in eliminating the color. I suspect this has been caused by badly rusted pipes or is entering the supply plumbing from the water supply. If it originates in the pipes of this house, deterioration that is this bad could necessitate near-term, if not immediate, replacement of the affected plumbing. This will require further assessment to determine the exact cause of the rust and to correct it.

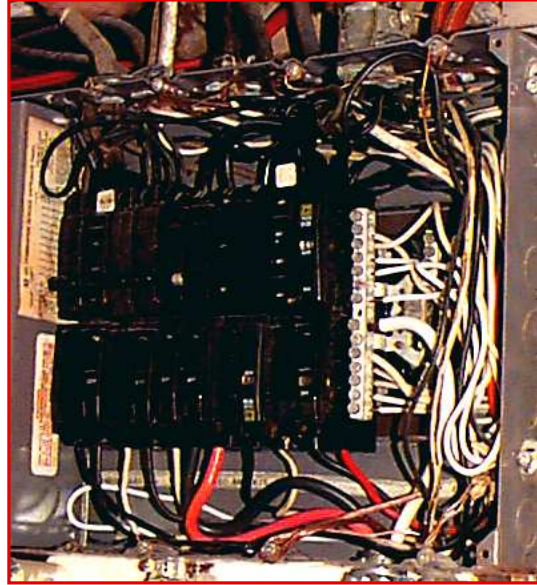
9) There is branch circuitry in this home wired with aluminum conductors. Aluminum wiring is of concern because it is softer, has a higher thermal expansion rate, is more likely to be nicked or otherwise damaged and because it corrodes when improperly connected to copper wiring, outlets, switches or fixtures that are not approved for use with aluminum. Any of these deficiencies can cause arcing or overheating or even result in a fire.

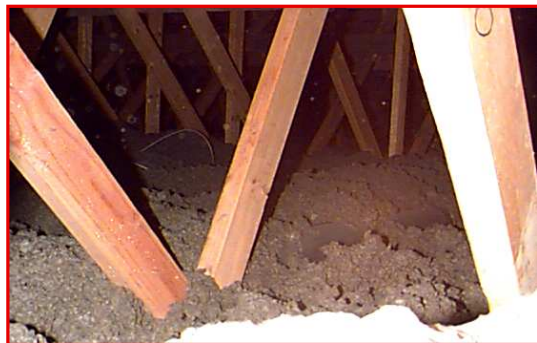
- 4) One or more bird nests were found at the perimeter of the attic. Birds gain entry by pecking at the mesh covering vents until they make a hole large enough for entry. Once inside, they will construct large nests that can eventually prevent proper ventilation. The nests can also be the source of lice infestation in a home. Re-screening the vents with 1/4-inch galvanized steel mesh no less than 22 gauge thick is recommended. Once re-screened, all nesting materials should be removed and the insulation restored to proper loft.
