Home Inspection Report

1234 Sample Rd.

Report Prepared For:
Sample Client

April 07, 2004

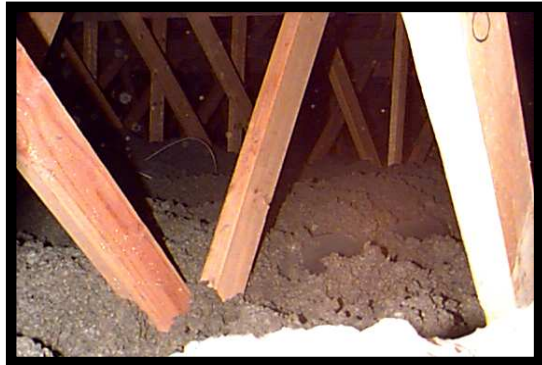
(b) It was found that the blown-in insulation in the attic above the second floor is in contact with the roof in nearly every other rafter bay between the frieze vents. This is an unsatisfactory condition, as moisture migrating up through the insulation will likely contact the cold underside of the roof, condense and then drip down to the ceilings below. Besides staining the ceilings, this could result in formation of mold in the insulation on top of the ceilings. There should

be about 1-1/2 to 2 inches of clearance between the insulation and the underside of the roof to avoid this type of issue. It is recommended that this be brought to the attention of the builder for correction.
